Manhole Inspection Summary

Manhole # S33EE_033MH

Location Address: **1123 MARYLAND AVE**

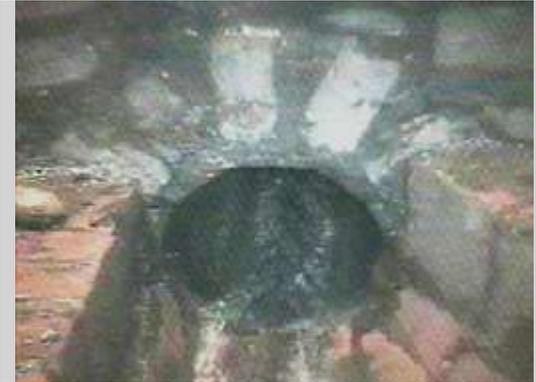
**8 in. Circular Gravity Sewer
Pipe Out @ 12 O'Clock**

Pipe Material: **Clay** Pipe Lined

Invert Depth: **11.27** (ft.) Flow Characteristics: **Fast**

Infiltration: **None** Pipe Seal Cond: **Unknown**

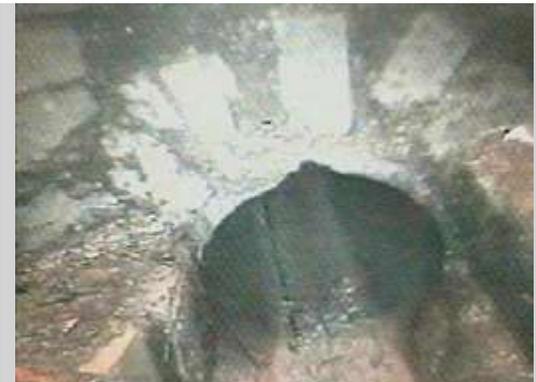
**8 in. Circular Gravity Sewer
Pipe In @ 3 O'Clock**

Pipe Material: **Clay** Pipe Lined

Infiltration: **None** Pipe Seal Cond: **Unknown**
